DEPARTMENT OF TRANSPORTATION

Contract #: 04-0120F4Cty: SF/ALA Rte: 80 PM: 13.2/13.9File #: 69.28**WELDING INSPECTION REPORT****Resident Engineer:**Siegenthaler, Peter**Address:** 333 Burma Road**City:** Oakland, CA 94607**Report No:** WIR-020515**Date Inspected:** 12-Feb-2011**Project Name:** SAS Superstructure**OSM Arrival Time:** 1500**Prime Contractor:** American Bridge/Fluor Enterprises, a JV**OSM Departure Time:** 2300**Contractor:** Zhenhua Port Machinery Company, Ltd (ZPMC), Changxing Island **Location:** Shanghai, China**CWI Name:** Mr. Sha Zi**CWI Present:** Yes No**Inspected CWI report:** Yes No N/A**Rod Oven in Use:** Yes No N/A**Electrode to specification:** Yes No N/A**Weld Procedures Followed:** Yes No N/A**Qualified Welders:** Yes No N/A**Verified Joint Fit-up:** Yes No N/A**Approved Drawings:** Yes No N/A**Approved WPS:** Yes No N/A**Delayed / Cancelled:** Yes No N/A**Bridge No:** 34-0006**Component:** OBG**Summary of Items Observed:**

WELDING INSPECTION REPORT

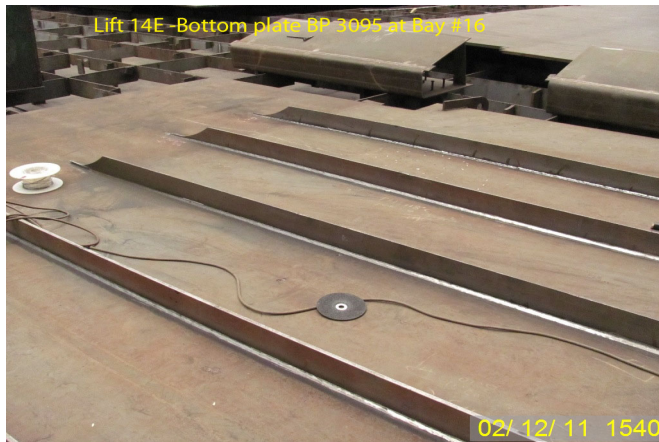
For further information see below pictures:-

Unless otherwise noted, all work observed on this date appeared to be in general compliance with the applicable contract documents.
